## Renishaw's inspection tools optimise VMC precision for Haas

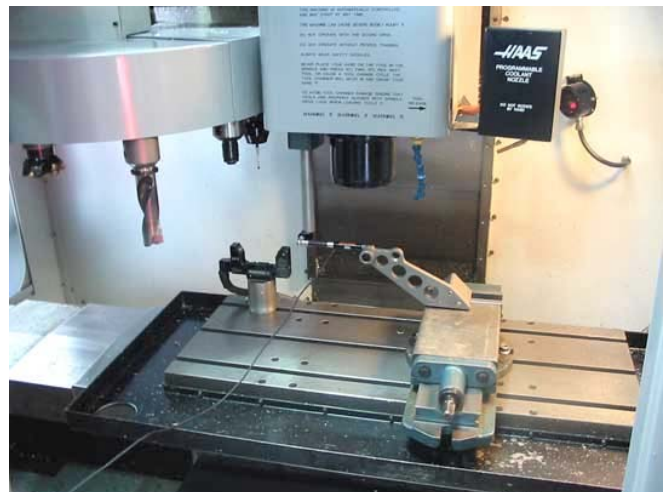
QC10 ballbar testing positioning performance on a HAAS VMC

Roth used the Ballbar to test the multi-axis movement of the VF-6 prototype in all three planes, X-Y, Y-Z and X-Z. This was followed by straightness and displacement measurements taken using the laser.

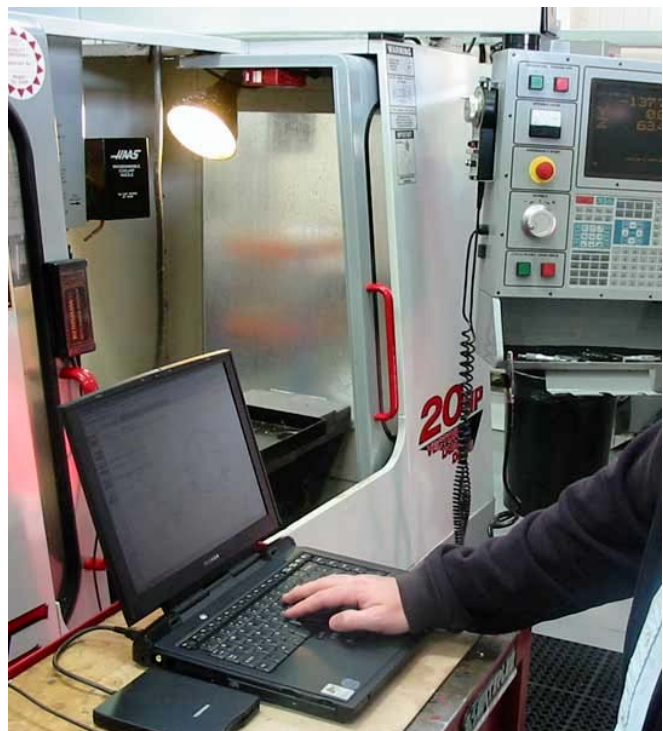
The QC10 ballbar test is controlled with software on a PC, the data gathered will then be analysed with Ballbar diagnostic software off-line

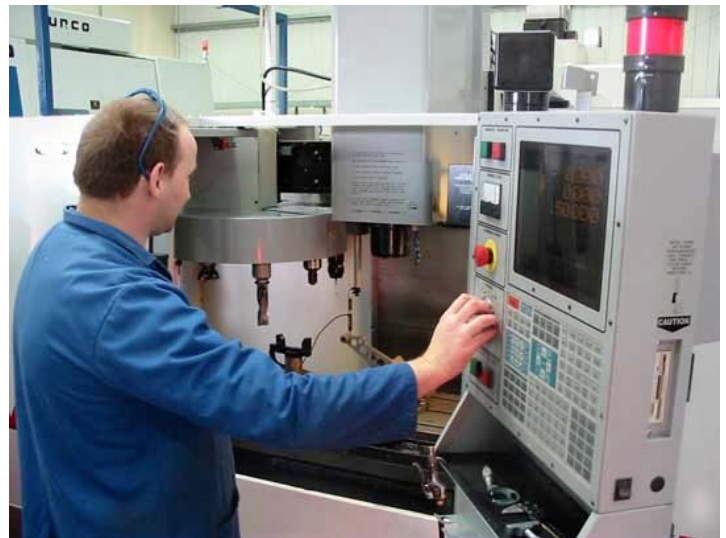
Following the ballbar test, adjustments can be made and the machine re-tested to provide a bench-mark for on-going historical analysis of the positioning performance, allowing predictive maintenance

Haas supplies a Ballbar circularity test plot with each new VMC shipped. Unique to the individual machine, the plot shows the trace of a 300 mm diameter circle in the X-Y plane, made at 25 or 50 ipm, depending on machine size. Through the precise match between an ideal circle and the Ballbar map of the machine's true movement, the customer sees graphic proof of the contouring accuracy of the machine. The test is frequently re-performed by Haas UK once the machine is installed at a customers' premises. Andrew Ward, Haas UK Engineering Director commented: "The Ballbar check is a straightforward test. We are happy to show the customer that his machine is just as accurate after it has travelled the 6,000 miles from California". He added. "We have also found the Renishaw Ballbar System invaluable as a diagnostic tool, if and when a problem does occur".
